LSR II Basic Troubleshooting Guide – Updated April, 2016

Aaron Rae, Technical Director, Emory + Children's Pediatric Flow Cytometry Core

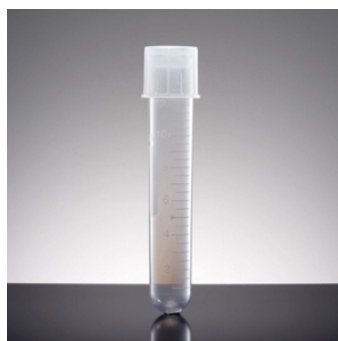
Incorrect - Polypropylene

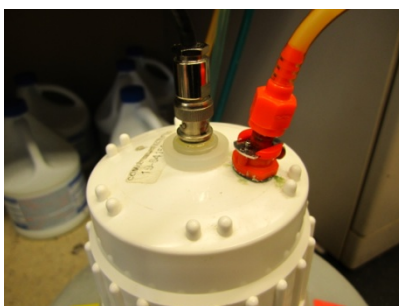
Waste Tank Connection Problems – Check Waste Tank Connectors

Incorrect

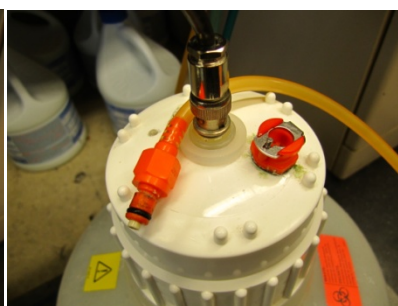
Incorrect

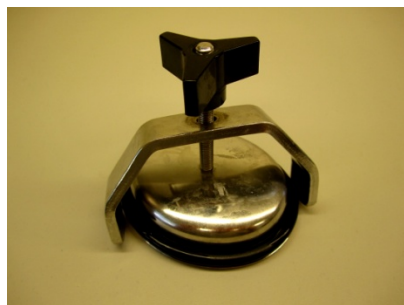
Correct- O-Ring Placement

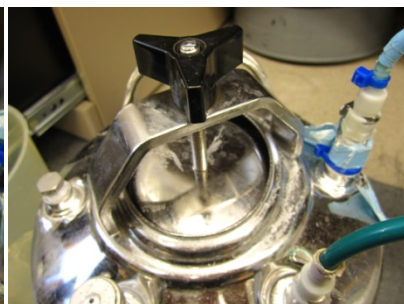
Sheath Tank Lid Issues – Check Lid is Sealed Properly and O-Ring is still in correct position

Incorrect – Lid Not Shut Fully

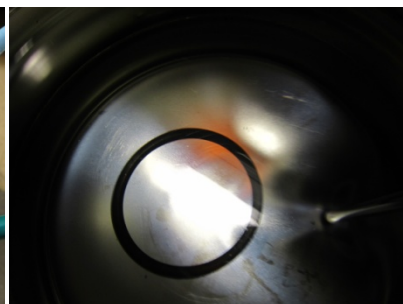
Incorrect – Lonely O-Ring!

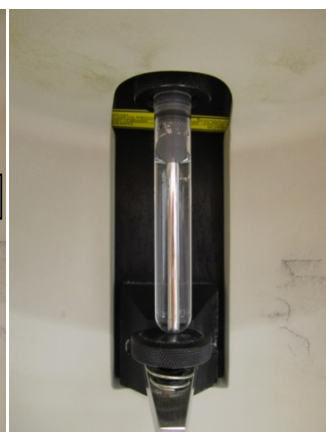
Overfilled Tubes – Leads to blockage of pressurization hole therefore incorrect pressurization of tubes.
(Maximum 3mL in tube as stated in SOP)

Incorrect

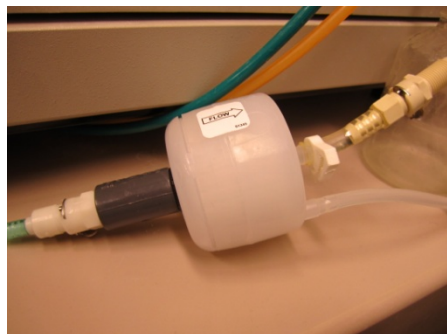
Air in the Sheath Filter – Remember to Bleed and Air from the Sheath Filter – Large Air bubbles will lead to decreased flow or possible blockages.

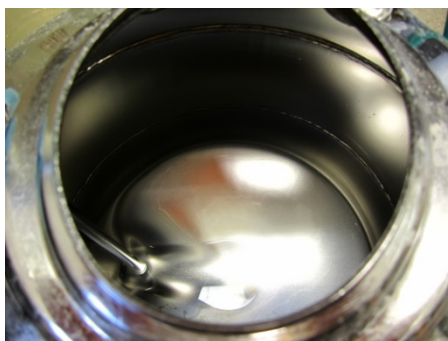
Instrument Run Dry

Incorrect
